A 6-Year Unloaded Hydroxyapatite-Coated Dental Implant Placed into an Extraction Socket in Conjunction with Nonresorbable Hydroxyapatite Grafting Material: Histologic Evaluation

A submerged hydroxyapatite (HA)-coated implant placed into a fresh extraction socket in conjunction with a nonresorbable HA graft was harvested after 6 years of unloaded healing. The implant and surrounding bone were processed for histologic analysis. The HA coating appeared to be stable and homogenous. An excellent bone-to-implant contact could be found along the entire implant length. No signs of HA resorption or detachment were found. The HA graft was still recognizable histologically around the apical third of the implant. Light microscopy revealed a good osteoconductive ability of the HA particles, which did not show any signs of remodeling or resorption. These findings suggest that HA-coated implants may be able to maintain optimal osseointegration over time, even in the absence of loading. (Int J Periodontics Restorative Dent 2002;22:575–581.)

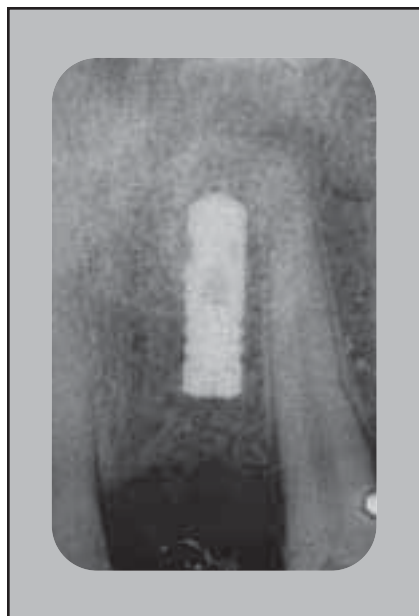
Fig 1 (left) Periapical radiograph taken during the initial evaluation. Implant in position of maxillary left central incisor shows no sign of periimplant radiolucency. Note the unfavorable position of the implant with respect to the cementoenamel junction of the adjacent teeth.

A 35-year-old man presented with a submerged implant that had been placed about 6 years before to replace the maxillary left central incisor. Clinically, no signs of infection were present, and radiographically, no radiolucency could be detected around the implant (Fig 1). The authors were able to obtain information regarding the implant history by contacting the clinician who had performed the implant surgery. The HA-coated implant (Sustain, Lifecore) had been placed immediately after extraction of the central incisor. The residual space was grafted with nonresorbable HA (Interpore 450, Interpore) so that the implant was completely submerged. No membrane was used, and primary closure was achieved. The patient provided a computed tomographic (CT) scan in which implant position and the grafting material were clearly identifiable (Fig 2). The implant was judged to be nonrestorable because of the extremely apical position. The treatment plan included implant removal and residual socket preservation to place, after healing, a new and prosthetically driven implant.

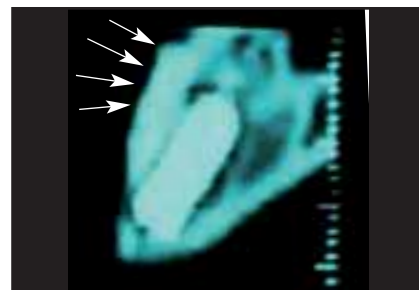
Fig 2 (right) CT scan of the area of the maxillary incisor. The HA graft appears as a dense and radiopaque area outside the envelope of basal bone (arrows). The coronal aspect of the implant is completely covered by bone.

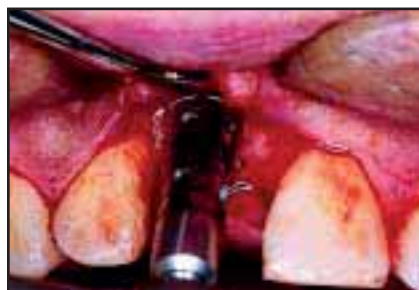
Fig 3 (left) Full-thickness flap is elevated, and 4-mm trephine bur is used to remove the osseointegrated implant together with the surrounding bone.

implant was found to be clinically immobile. At this point, using a 4-mm-diameter trephine bur, the implant and surrounding bone were harvested (Figs 3 and 4). The biopsy (Fig 5) was immediately immersed in a 10% formaldehyde buffered fixation solution. The residual defect was grafted with demineralized freeze-dried bone allograft (LifeNet) and covered with a resorbable barrier membrane (Guidor). Primary closure was achieved with tension-free sutures.

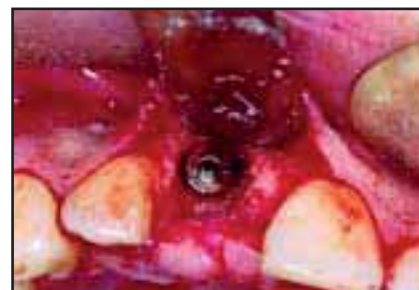
Fig 4 (right) Implant in situ after trephine bur action and just before removal. Care was taken not to damage the adjacent teeth or perforate the buccal cortical plate.

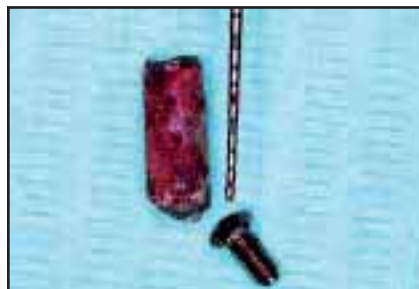
Fig 5 (left) Ten-millimeter-long implant just after harvesting. Note the retained alveolar bone covering the implant body.

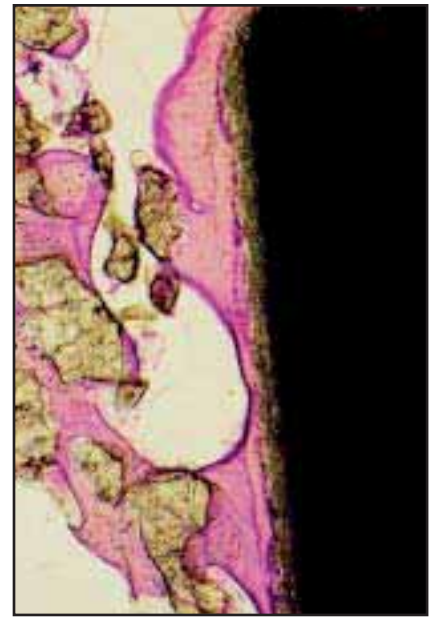
Fig 9 Apical third of the implant body, as indicated by area C in Fig 6. HA particles are clearly identifiable. Note the intimate contact between alveolar bone and graft particles. No signs of inflammatory infiltrate or fibrous encapsulation are evident. The sharp geometry of the particles may suggest that no remodeling of the graft is taking place (hematoxylin-eosin stain; original magnification $\times 100$).

marrow spaces. Apical to the implant body, residual fragments of HA grafting material were clearly identifiable (Fig 9). The particles were closely related to the implant and embedded in a bone matrix, without any fibrous tissue encapsulation. No inflammatory infiltrate could be seen, and the sharp geometry of the particles suggested that no remodeling of the fragments had taken place.
